Manhole Inspection Summary

Manhole # S27E__013MH

Insp Date: **8/21/07 11:13 AM**

Location Address: **931 LEXINGTON ST**

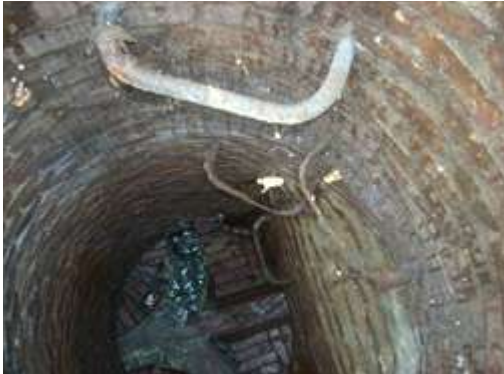
Defect 3

Count: **5** Missing: **0** ☒ **Corroded**

CORRODED STEPS

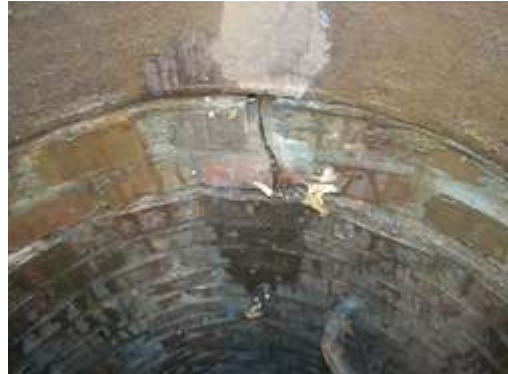
Defect 2

Infiltration: ☐ None ☐ Joint ☒ **Cracks** ☐ Mortar ☐ Roots ☐ Wall

INFILTRATION FROM CORBEL
CRACKS

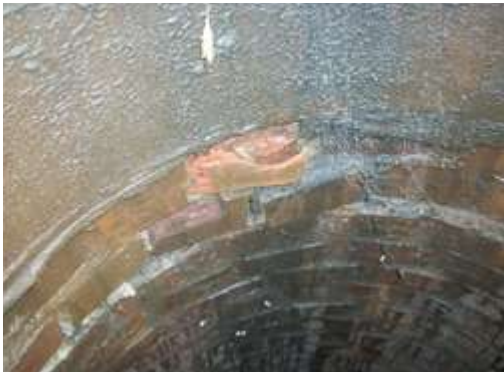
Defect 1

Condition: ☐ Sound ☒ **Cracked** ☐ Root Intrusion ☐ Loose Brick ☒ **Deteriorated**

DETERIORATED CORBEL

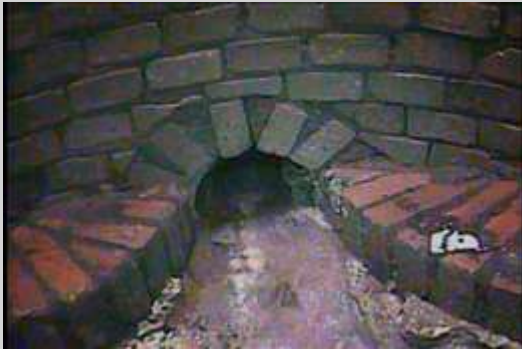
12 O'Clock Outflow

Pipe Height: **8.4** (in.) Rod and Bar (Angled)
Pipe Material: **Clay** ☐ Pipe Lined
Invert Depth: **12.03** (ft.) Flow Characteristics: **Fast**
Deposits: ☐ None ☐ Mud ☐ Sludge ☐ Debris ☒ Grease
Silt Depth: **2** (in.) Deposits Extent: **Light**
Infiltration: **None** Pipe Seal Cond: **Sound**

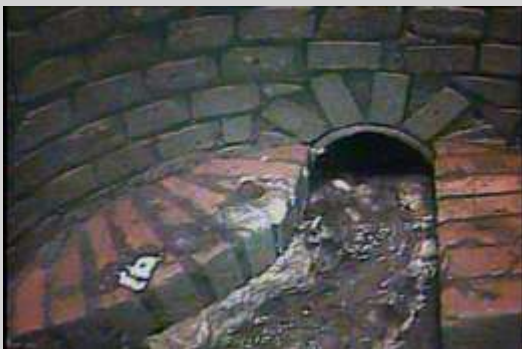
3 O'Clock Inflow

Pipe Height: **7.2** (in.) Rod and Bar (Angled)
Pipe Material: **Clay** ☐ Pipe Lined
Invert Depth: **11.86** (ft.) Flow Characteristics: **Slow**
Deposits: ☐ None ☐ Mud ☐ Sludge ☒ Debris ☐ Grease
Silt Depth: **4** (in.) Deposits Extent: **Medium**
Infiltration: **None** Pipe Seal Cond: **Sound**

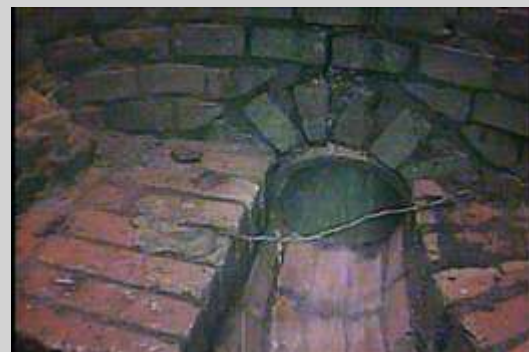
Drop In @ 9 O'Clock

CORRODED STEPS
